# (KID) Kearns Improvement District Non-Lead Submittal

## Written Statement on Lead and Galvanized Pipe Findings in the Kearns Improvement District

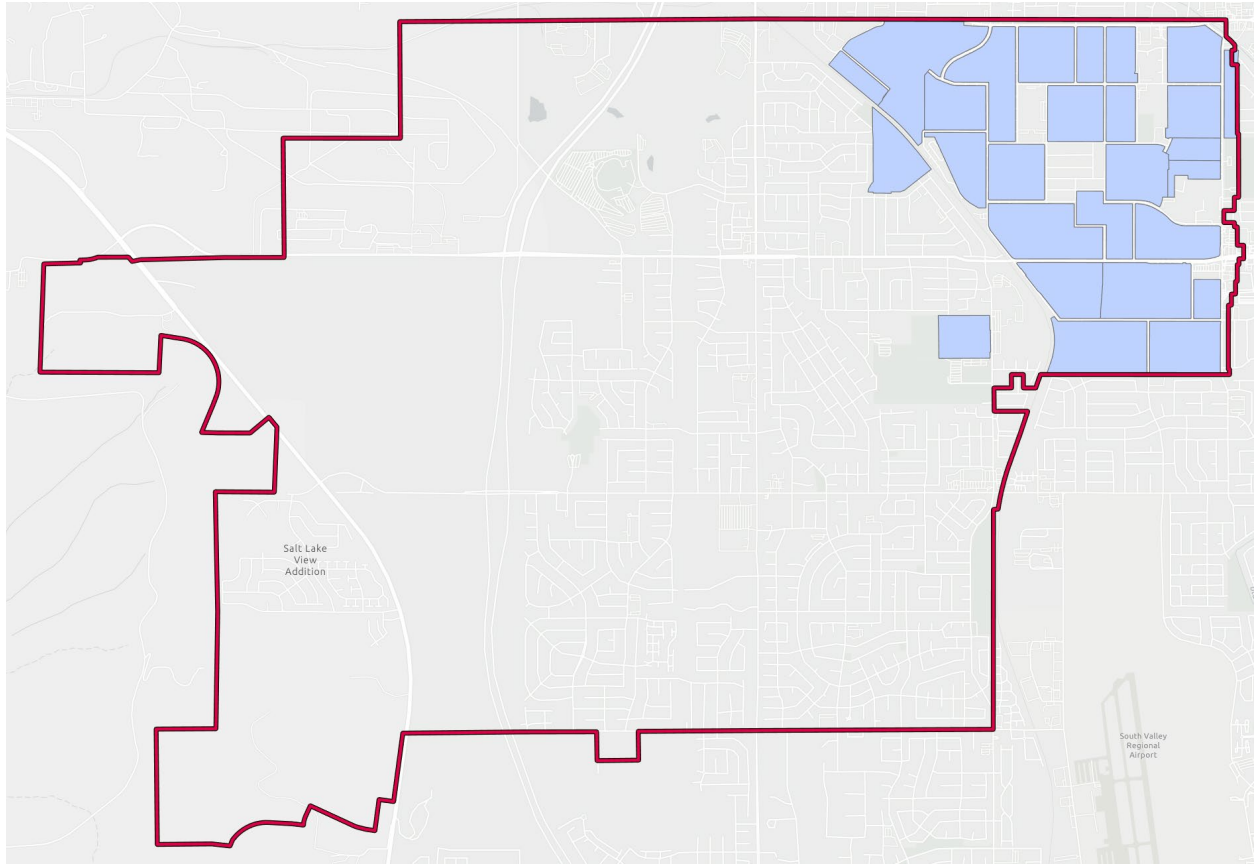
111-29-C

The verified information was then mapped to provide a visual representation of the neighborhoods with documented copper pipe installations. The map included blue polygons representing areas where documentation confirmed the original installation of copper pipes. This visualization helped in easily identifying and verifying these locations.

The review of historical construction documents confirmed the original installation of copper pipes in several neighborhoods within the district. The mapped data, represented by blue polygons, provided a clear visual confirmation of these findings.

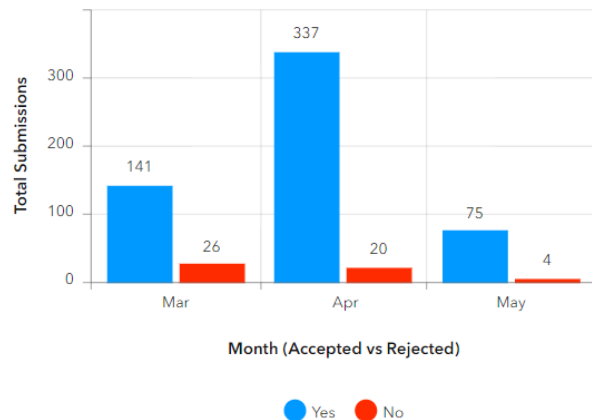
### Total Number of Survey Submissions Per Month

Responses were automatically mapped and reviewed for completeness and accuracy, with 553 responses accepted for use in the project.
